Commercial

Maryville Courts

Core Civil Solutions

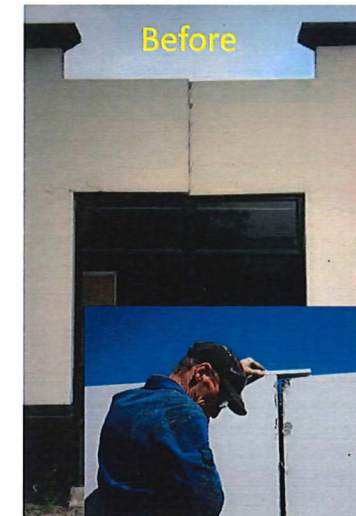
Before Re-levelling

- This particular building is an office with heavy precast concrete walls and is attached to a warehouse.
- The front right and left hand corners dropped approximately 70 mm and 15 mm, respectively.
- The settlement created an apparent drop of the concrete wall on the right hand side.

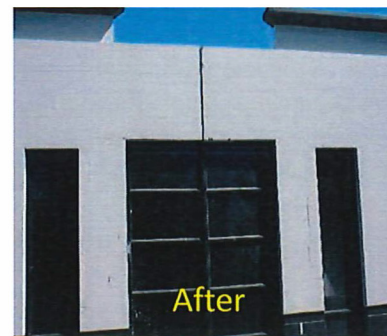
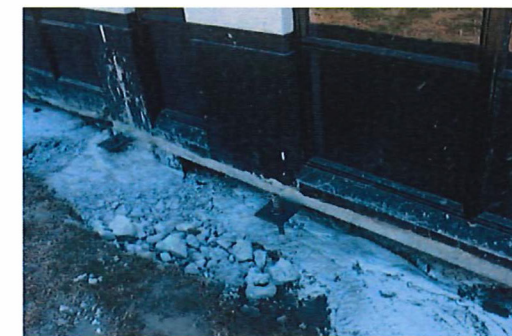
After Re-levelling

- Eleven piles (7 meters deep) were installed around the building. The job was done within 8 days.
- The final levels of the property are within the acceptable DBH tolerance of ± 15 millimeters.

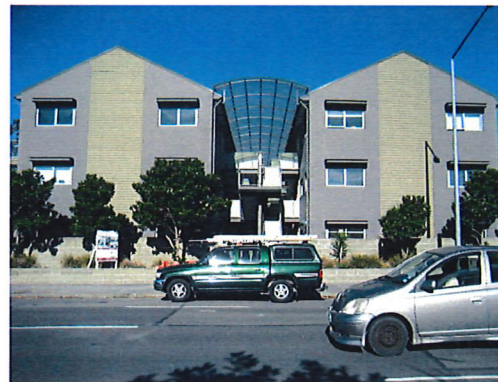
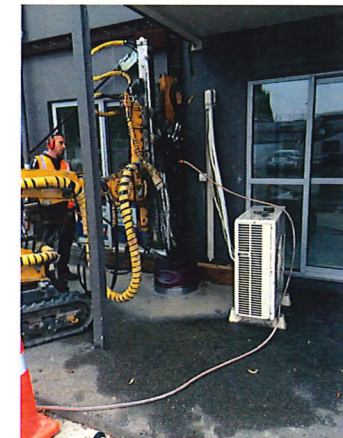
After Re-levelling

- This particular building is a three Storey, dual-wing apartment block with 34 units constructed of Tilt-slab concrete
- The site soil conditions were Gravel, Silt and Peat with a high water table.
- The rear of each wing had dropped by 316mm and 266mm, respectively.
- For the duration of the lift the tenants continued to occupy the upper two floors
- All services (sewer & storm water) remained connected for the duration of the work

- Work was completed in stages (One wing at a time & then the lift shaft & stairs)
- 113 piles (3 meters deep) were installed around the building.
- Both apartment block wings and the free standing lift shaft were relevelled
- The maximum lift was 230mm

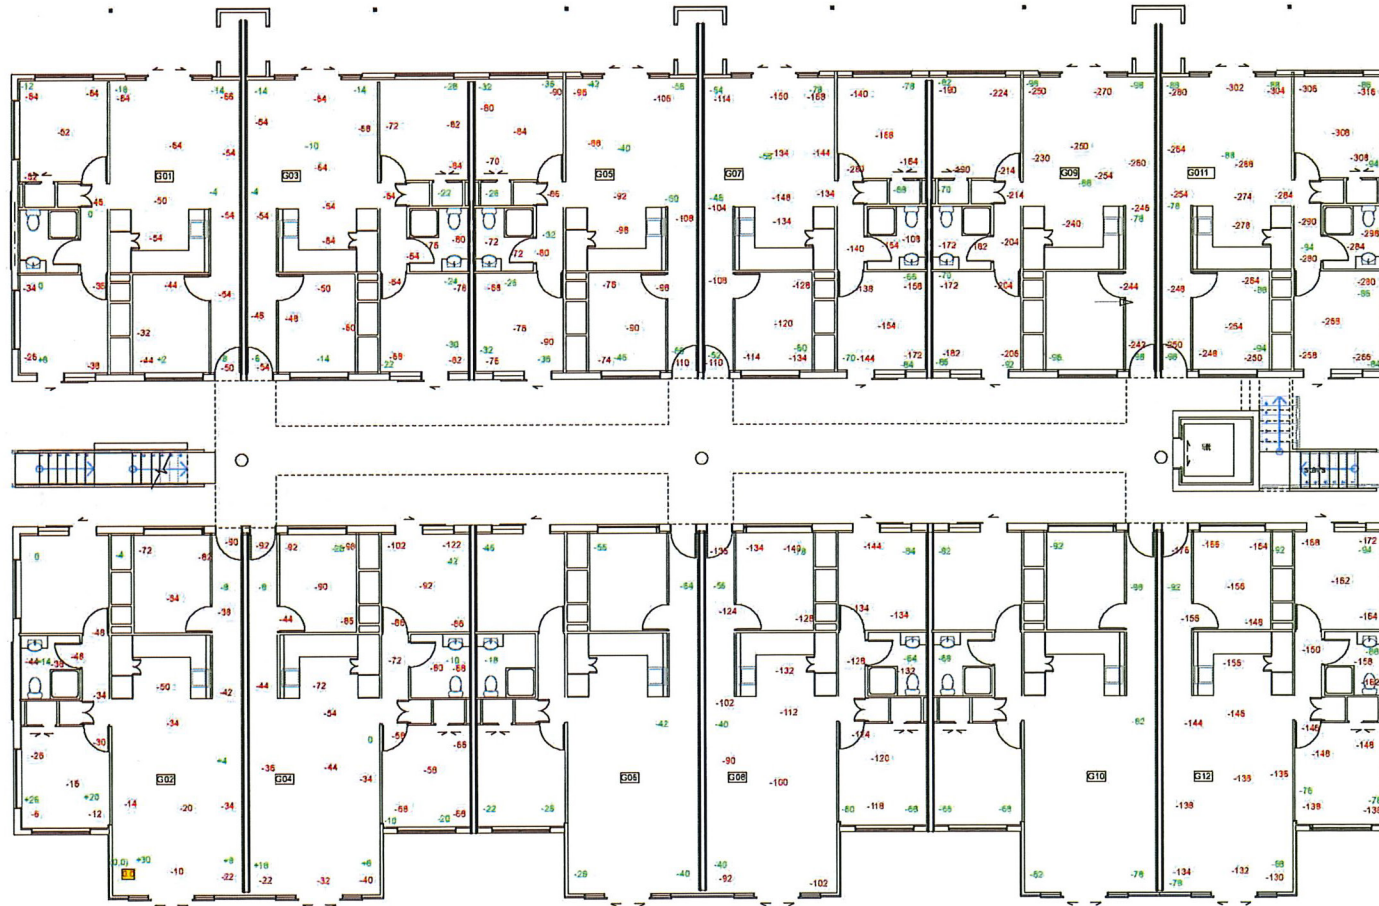
Site Plan / Pile Layout / Site Levels

-4 Before Relieving
-4 After Relieving

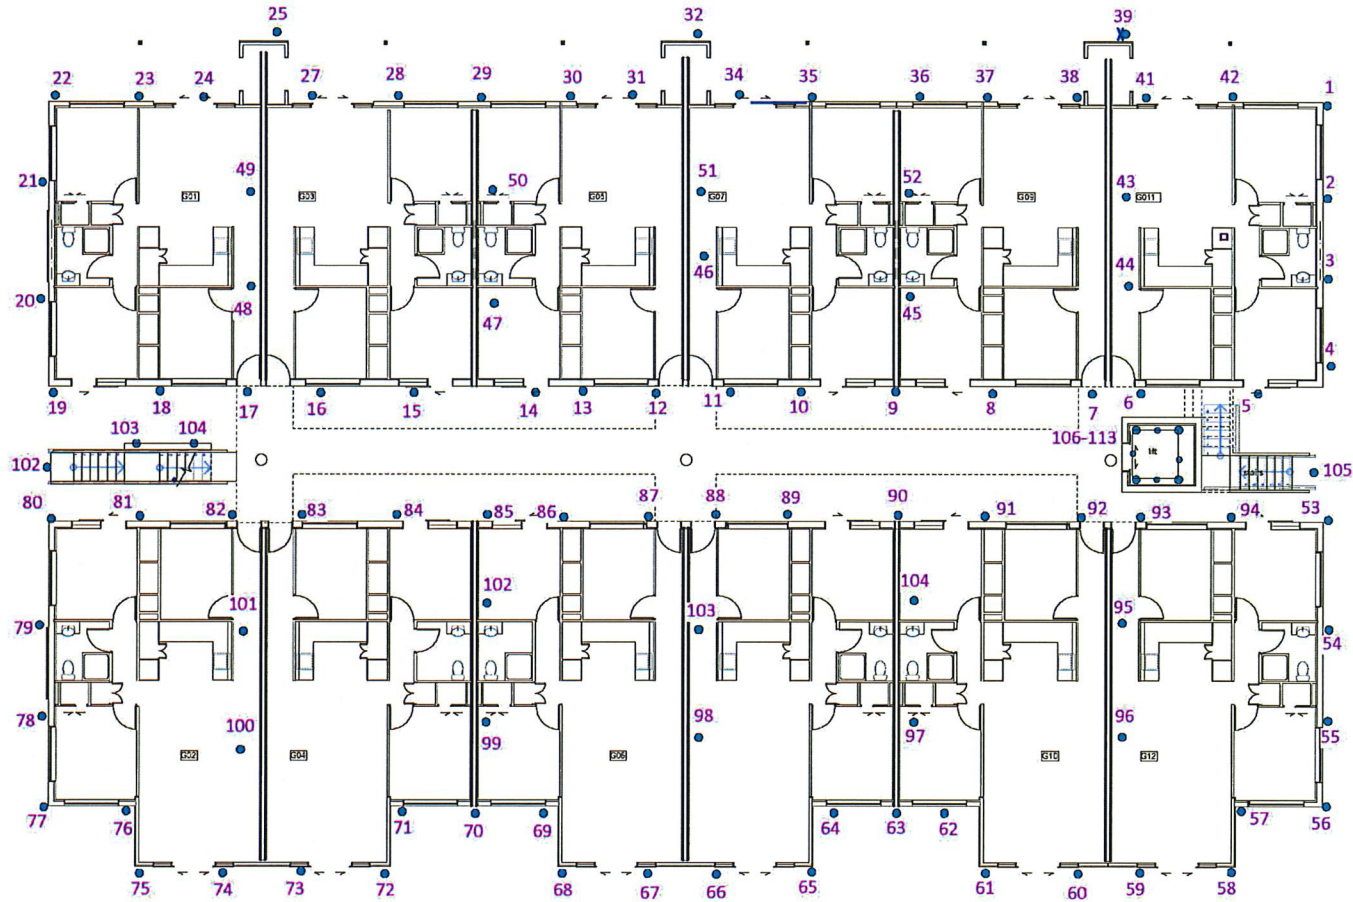
As built columns

1 ● As built Columns

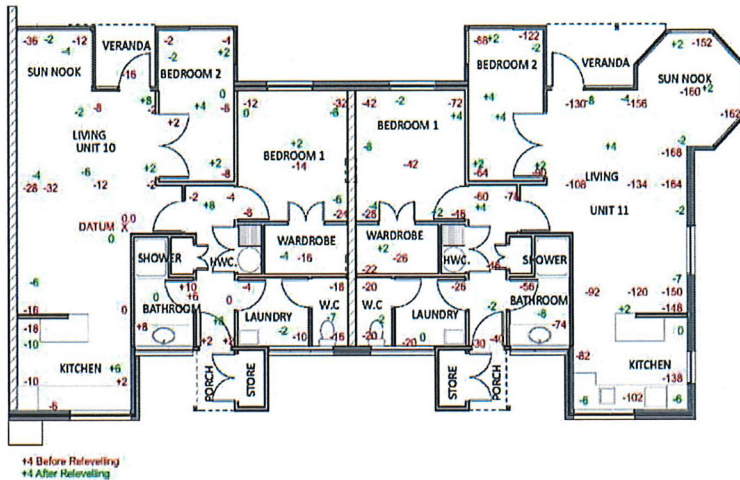
Stage 1- Villa 10 & 11

Area of Work (m ²)	150
Total variance from datum	172mm
Foundation Type	Type C – Slab on Grade
Amount Lifted	160mm
Repair Methodology	CCS Solution C
Time Duration (Days)	30

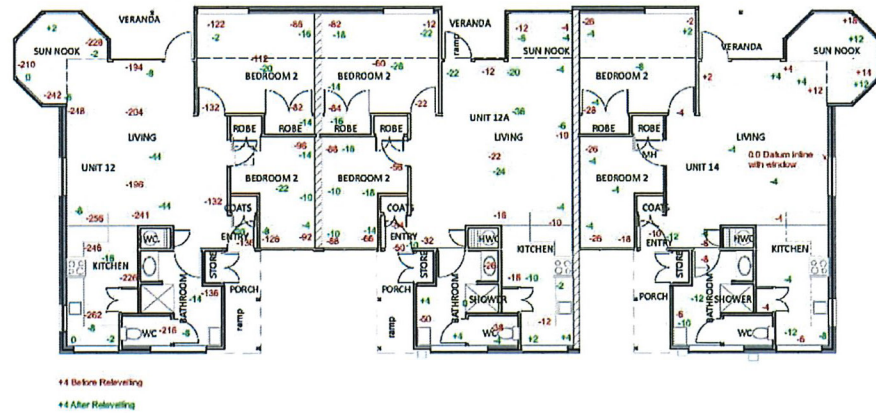
Stage 2- Villas 12-14

Area of Work (m ²)	150
Total variance from datum	262mm
Foundation Type	Type C – Slab on Grade
Amount Lifted	218mm
Repair Methodology	CCS Solution C
Time Duration (Days)	27

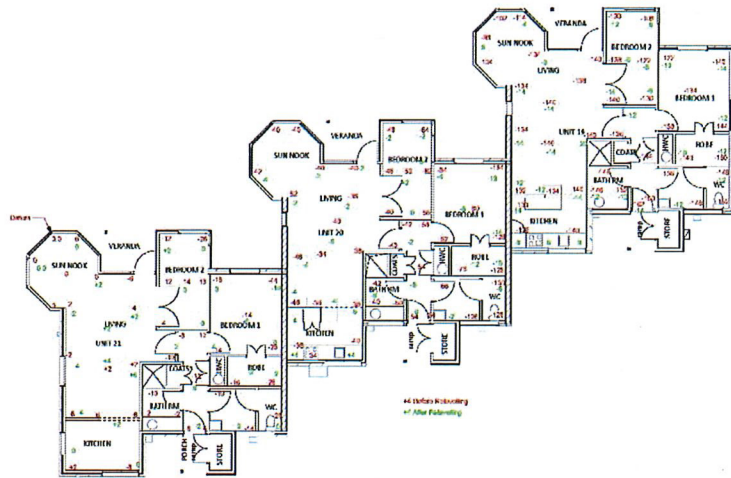
Stage 3- Villas 19-21

Area of Work (m ²)	241
Total variance from datum	152mm
Foundation Type	Type C – Slab on Grade
Amount Lifted	140mm
Repair Methodology	CCS Solution C
Time Duration (Days)	22

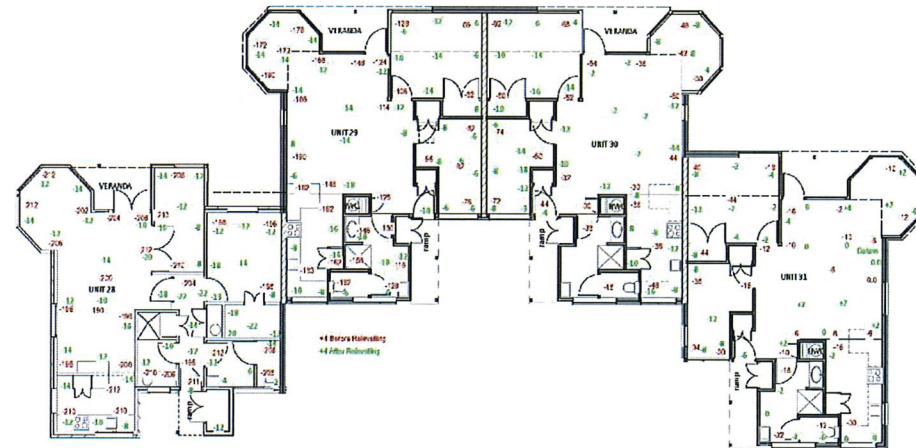
Stage 4- Villas 28-31

Area of Work (m ²)	306
Total variance from datum	212mm
Foundation Type	Type C – Slab on Grade
Amount Lifted	200mm
Repair Methodology	CCS Solution C
Time Duration (Days)	32

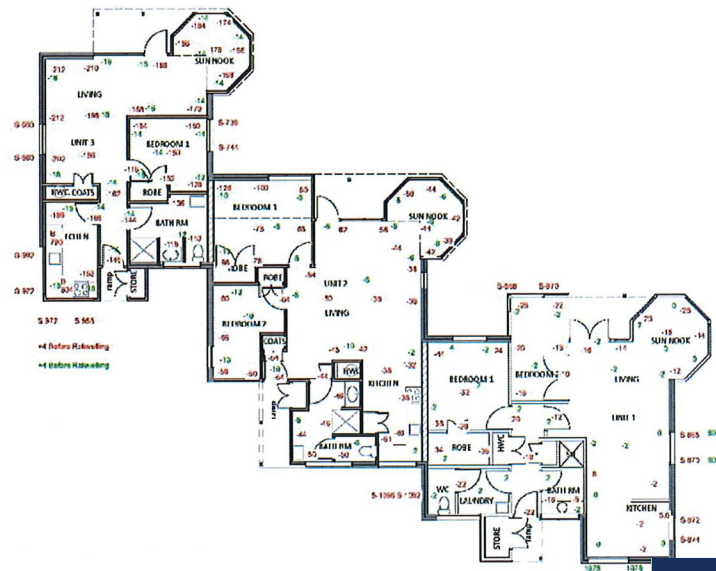
Stage 5- Villas 1-3

Area of Work (m ²)	215
Total variance from datum	212mm
Foundation Type	Type C – Slab on Grade
Amount Lifted	194mm
Repair Methodology	CCS Solution C
Time Duration (Days)	25

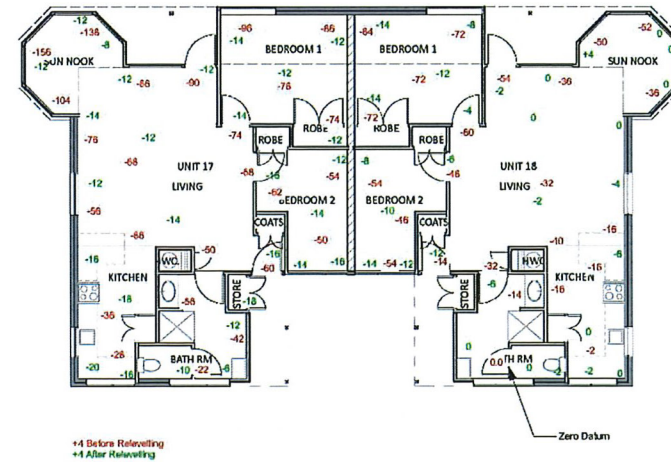
Stage 6- Villas 17 & 18

Area of Work (m ²)	152
Total variance from datum	156mm
Foundation Type	Type C – Slab on Grade
Amount Lifted	132mm
Repair Methodology	CCS Solution C
Time Duration (Days)	12

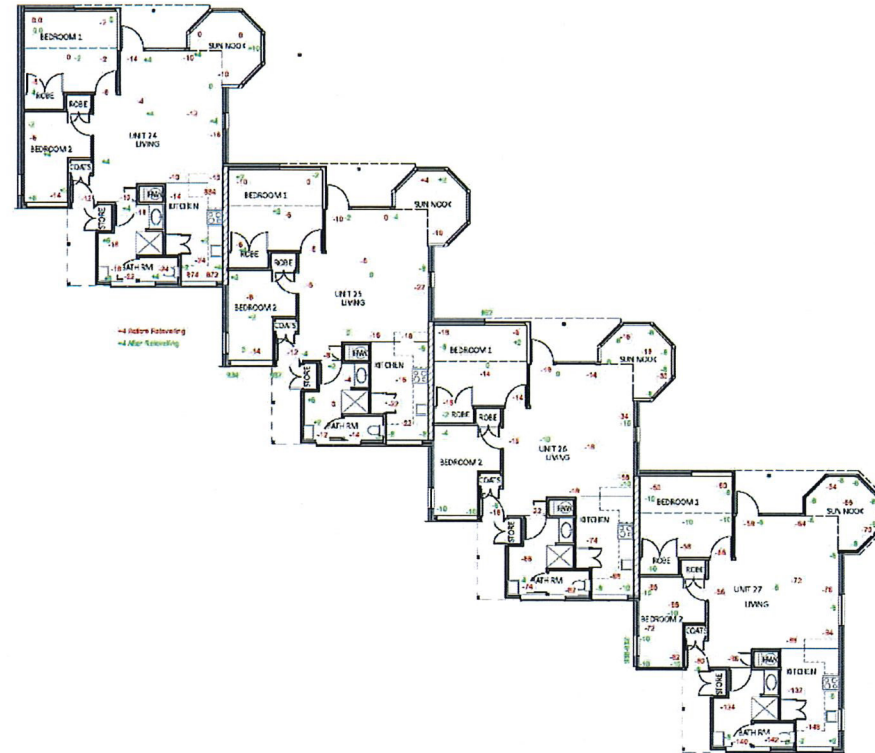
Stage 7- Villas 24-27

Area of Work (m ²)	152
Total variance from datum	156mm
Foundation Type	Type C – Slab on Grade
Amount Lifted	132mm
Repair Methodology	CCS Solution C
Time Duration (Days)	15
