Commercial

Maryville Courts

Core Civil Solutions

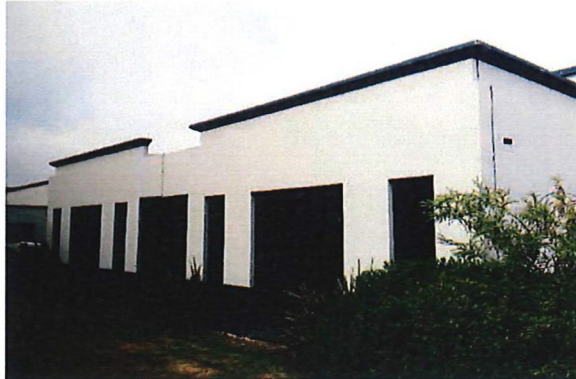
Area of Work (m ²)	69.7
Property Perimeter (m)	34
Foundation Type	Type C – Slab on Grade with thick perimeter beam
Water Table (m. BGL)	N/A
Repair Methodology	CCS Solution A + site specific technique
Time Duration (Days)	8

- This particular building is an office with heavy precast concrete walls and is attached to a warehouse.
- The front right and left hand corners dropped approximately 70 mm and 15 mm, respectively.
- The settlement created an apparent drop of the concrete wall on the right hand side.

- Eleven piles (7 meters deep) were installed around the building. The job was done within 8 days.
- The final levels of the property are within the acceptable DBH tolerance of ± 15 millimeters.

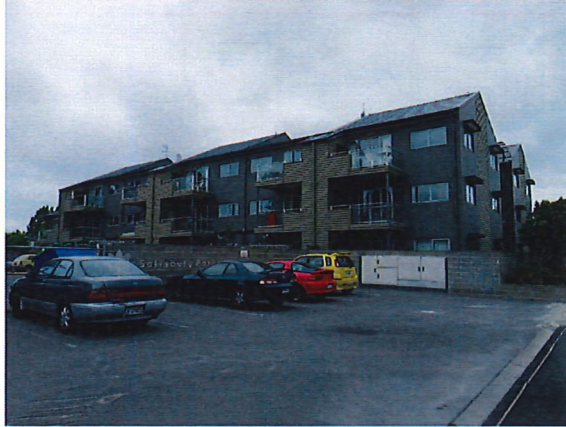
Area of Work (m ²)	842
Property Perimeter (m)	231
Foundation Type	Type C – Slab on Grade
Water Table (m. BGL)	0.7
Repair Methodology	CCS Solution C + site specific technique
Time Duration (Days)	126

- This particular building is a three Storey, dual-wing apartment block with 34 units constructed of Tilt-slab concrete
- The site soil conditions were Gravel, Silt and Peat with a high water table.
- The rear of each wing had dropped by 316mm and 266mm, respectively.
- For the duration of the lift the tenants continued to occupy the upper two floors
- All services (sewer & storm water) remained connected for the duration of the work

- Work was completed in stages (One wing at a time & then the lift shaft & stairs)
- 113 piles (3 meters deep) were installed around the building.
- Both apartment block wings and the free standing lift shaft were relevelled
- The maximum lift was 230mm

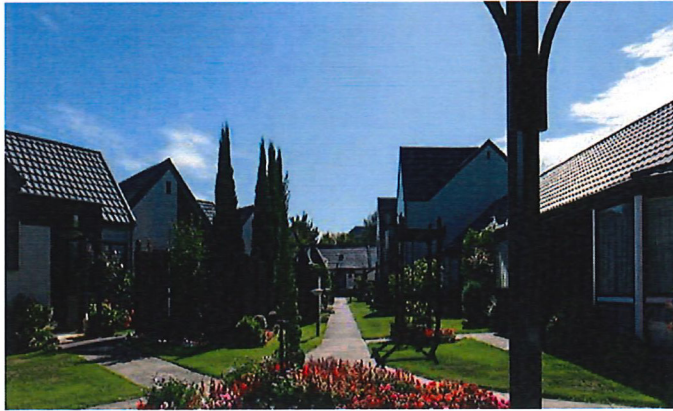
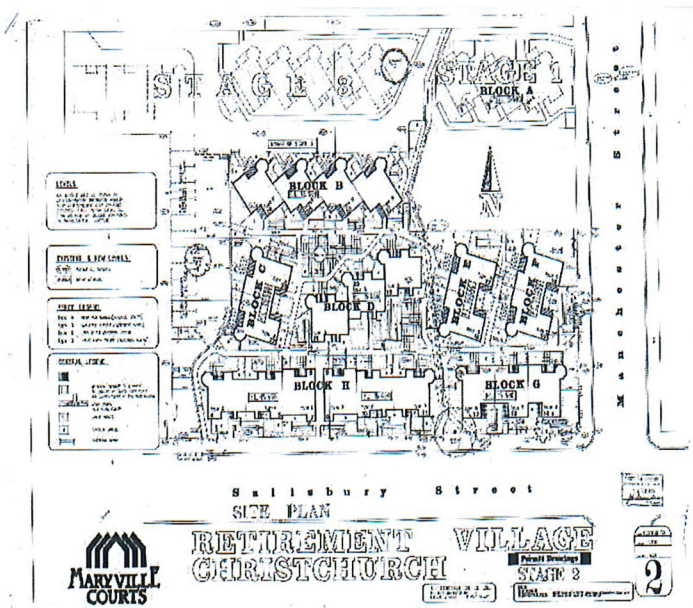
- The Villas were constructed of concrete block walls & timber cladding, lightweight shingle roof and concrete slab on grade construction and adjoining villas are separated by a reinforced concrete block firewall.

- The soil conditions varied across the site with Sand, Silts, Clay & Peat being found at different depths & zones.
- The water table was found at 1.5 bgl

- The villas all had differential settlement across the Slab & ring foundation. CCs successfully lifted the units to bring them back within the target levels with a maximum lift of 218mm

- CCS provided the full package for the village including drawings/plans, Council exemption, geotechnical report, engineering PS1 & PS4 for each stage.
- All villas in each stage were successfully re-levelled with a variation in the level from the datum of a maximum of 44mm

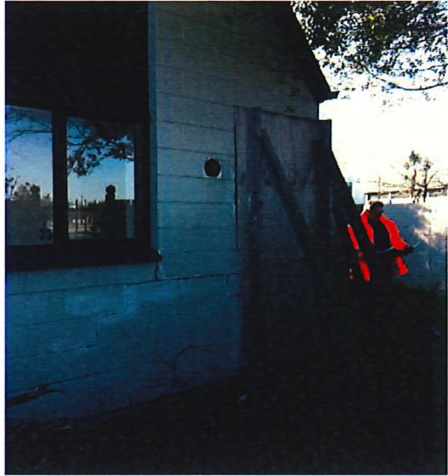
Stage 1- Villa 10 & 11

Area of Work (m ²)	150
Total variance from datum	172mm
Foundation Type	Type C – Slab on Grade
Amount Lifted	160mm
Repair Methodology	CCS Solution C
Time Duration (Days)	30
